# *El Mirage Rd; 303L – Jomax Road Design*

## *ADA Compliance and Feasibility Report*

ADOT Project No: T0428 03D

Contract No: 2024-001

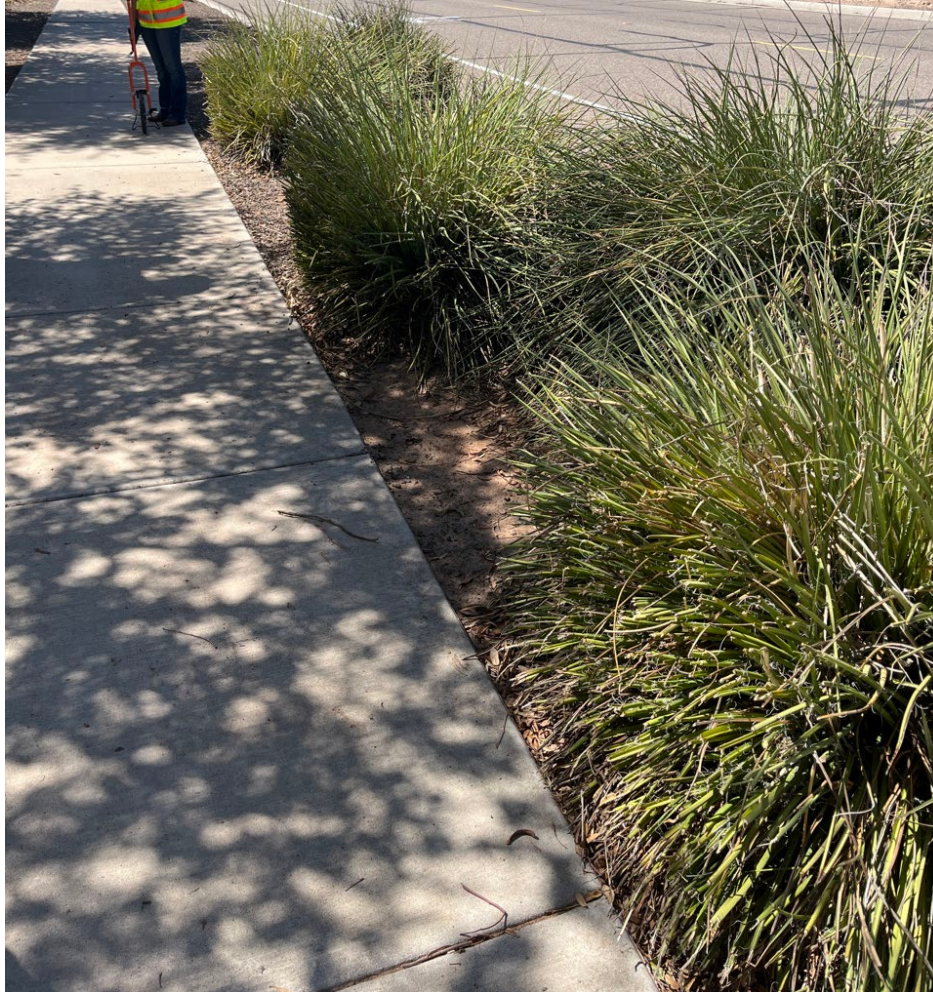
**Figure 5: Bushes Adjacent to Sidewalk**

No visible pedestrian obstructions were observed within the project area. From approximately 500 feet to 750 feet south of the intersection of El Mirage Road and Coldwater Ranch Drive, bushes adjacent to the sidewalk had been trimmed back outside the limit of the sidewalk. If the bushes are not maintained, the bushes have the potential to become a sidewalk obstruction. **Figure 5** displays a typical location where the bushes have been trimmed.

Existing tree canopies are present above the sidewalk. Trees should be maintained to provide at least 80 inches of vertical clearance above the sidewalk as detailed in PROWAG section 402.4.

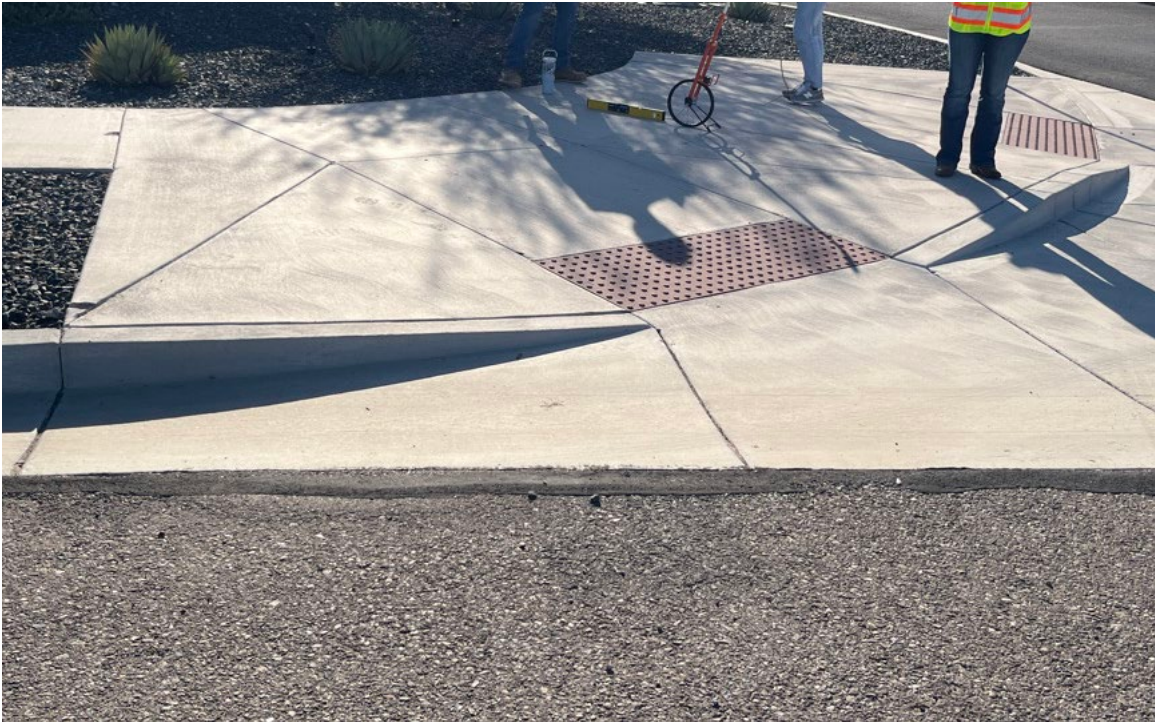
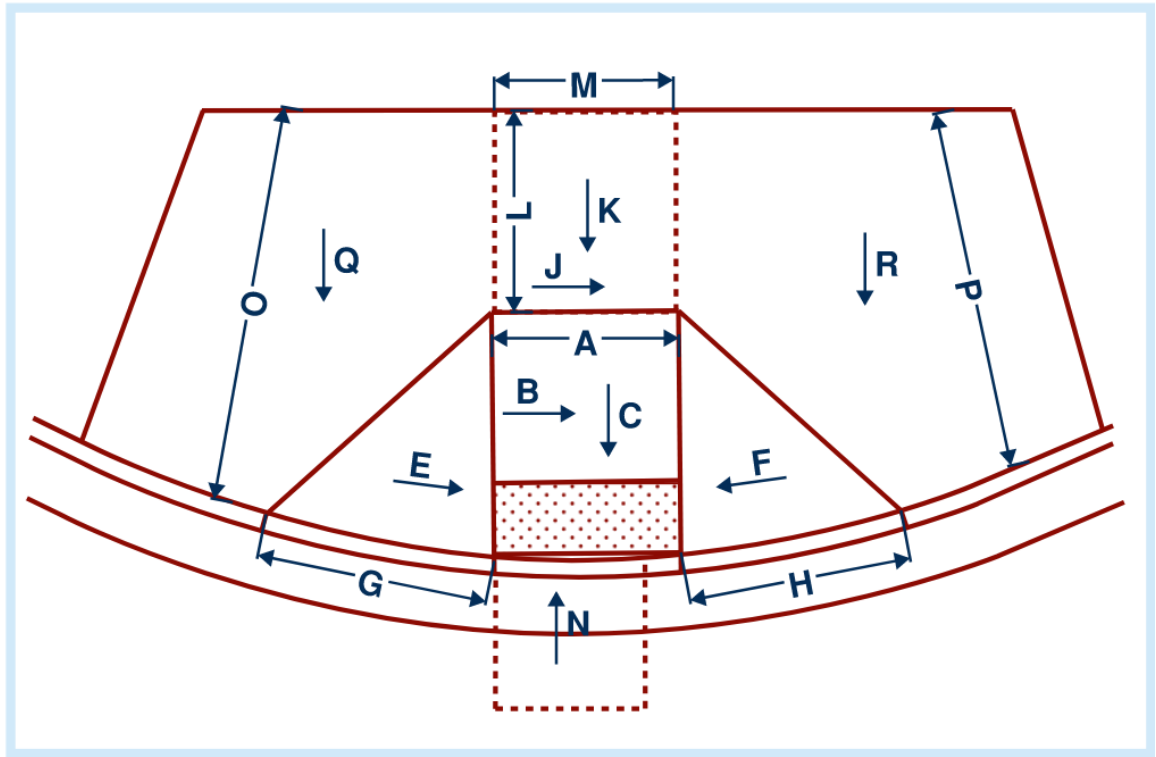
## Curb Ramp 1

**ADA Compliance**  
Non-Compliant

**Comments**  
Ramp is non-compliant due to top landing  
cross slope being greater than curb ramp  
cross slope.

| Facility ID | Feature not Meeting PROWAG | Proposed Remediation |
|---|---|---|
| R-1 | Landing cross slope greater than ramp cross slope | Reconstruct curb ramp |

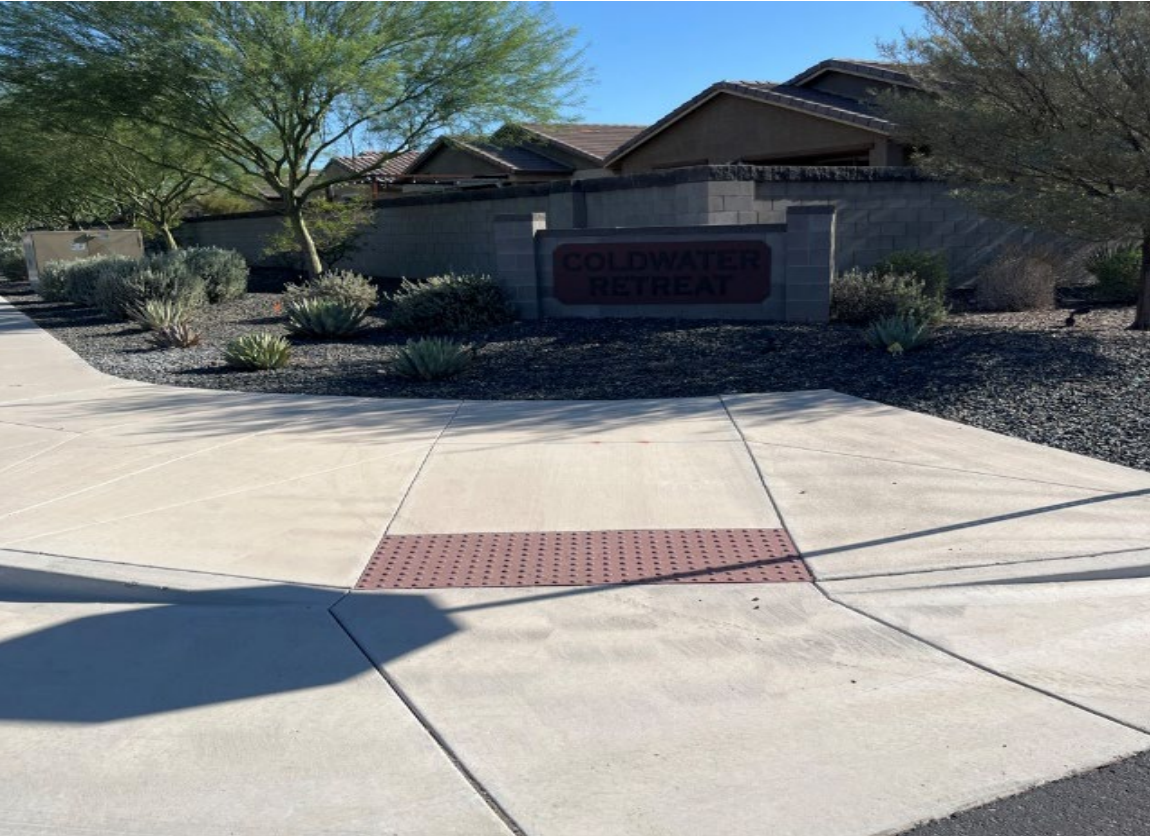
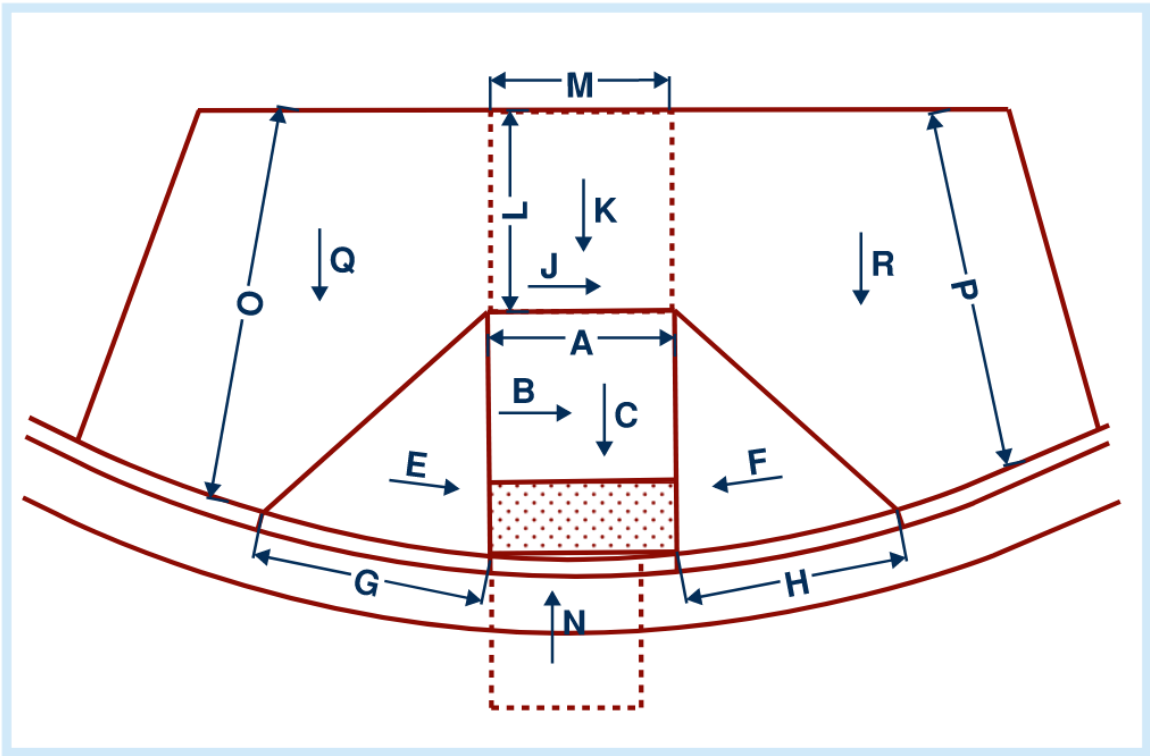
## Curb Ramp 2

**ADA Compliance**  
Non-Compliant

**Comments**  
Ramp is non-compliant due to top  
landing cross slope being greater  
than curb ramp cross slope.

| Facility ID | Feature not Meeting PROWAG | Proposed Remediation |
|---|---|---|
| R-2 | Landing cross slope greater than ramp cross slope | Reconstruct curb ramp |

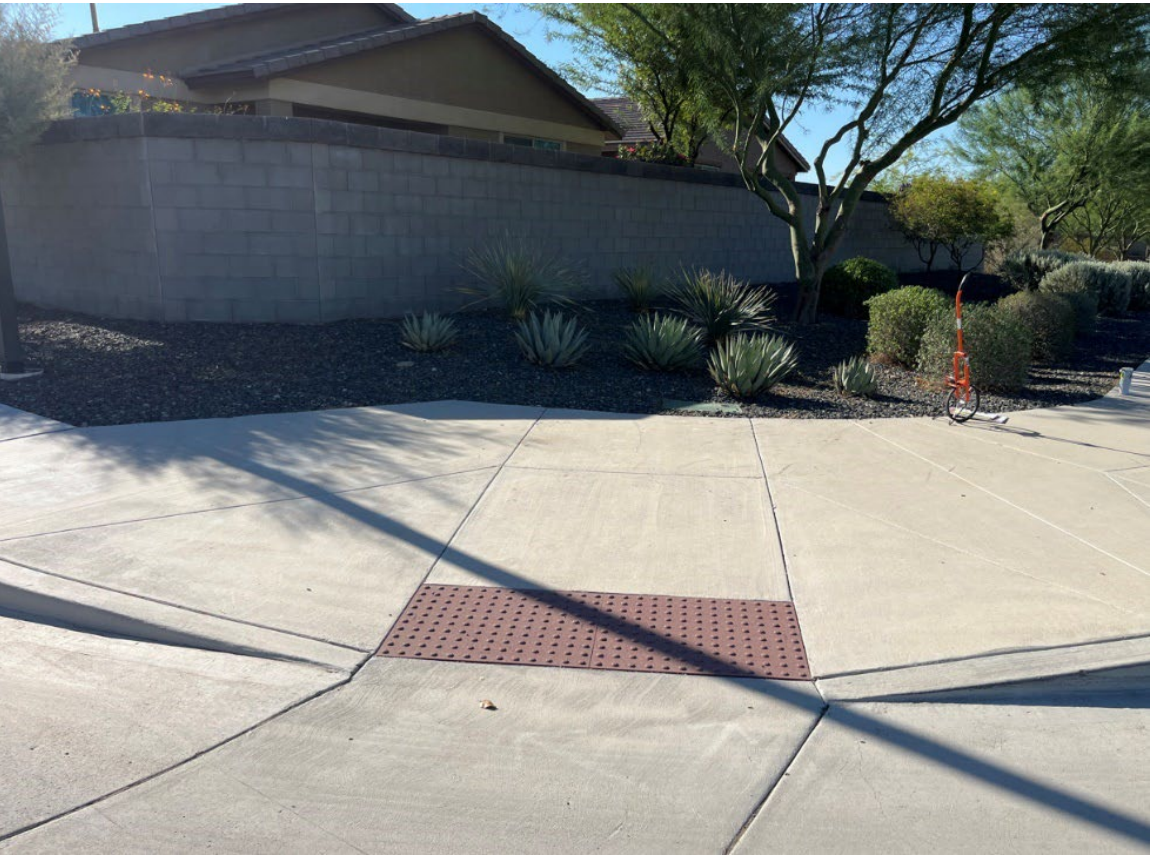
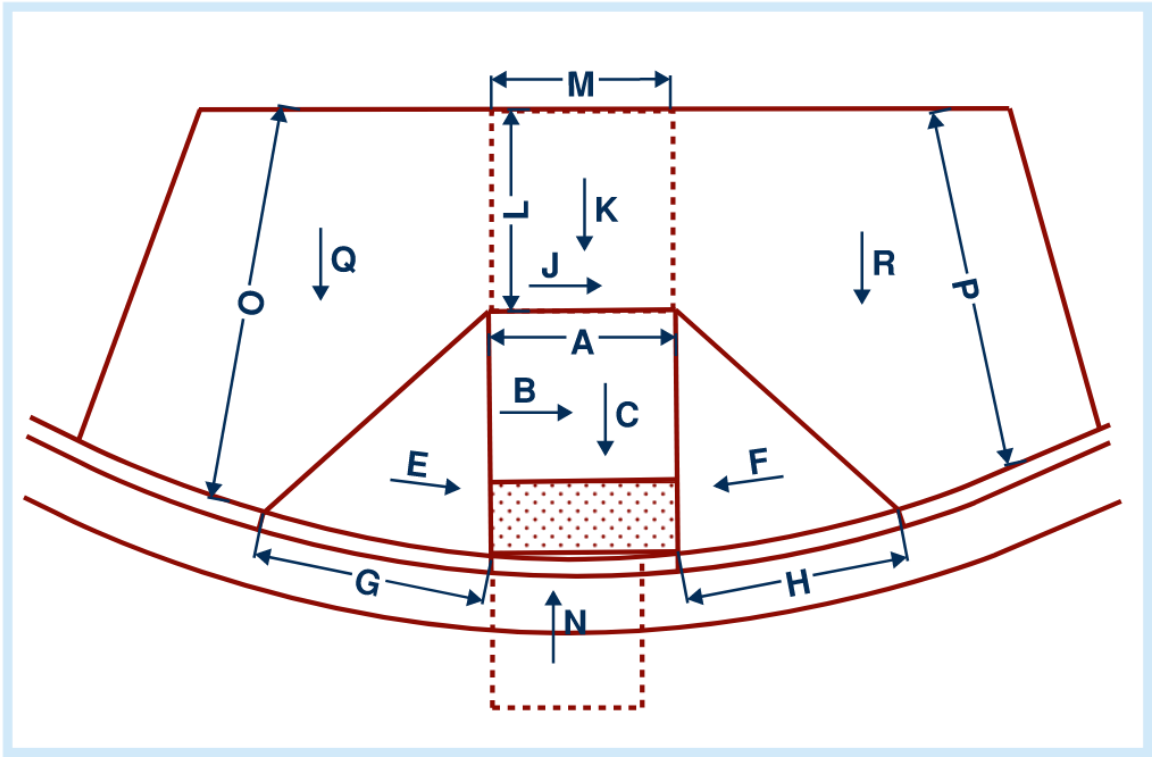
### Curb Ramp 3

**ADA Compliance**  
Compliant

**Comments**  
Surface damage observed including  
scratches, poorly screened areas, and  
cracking.

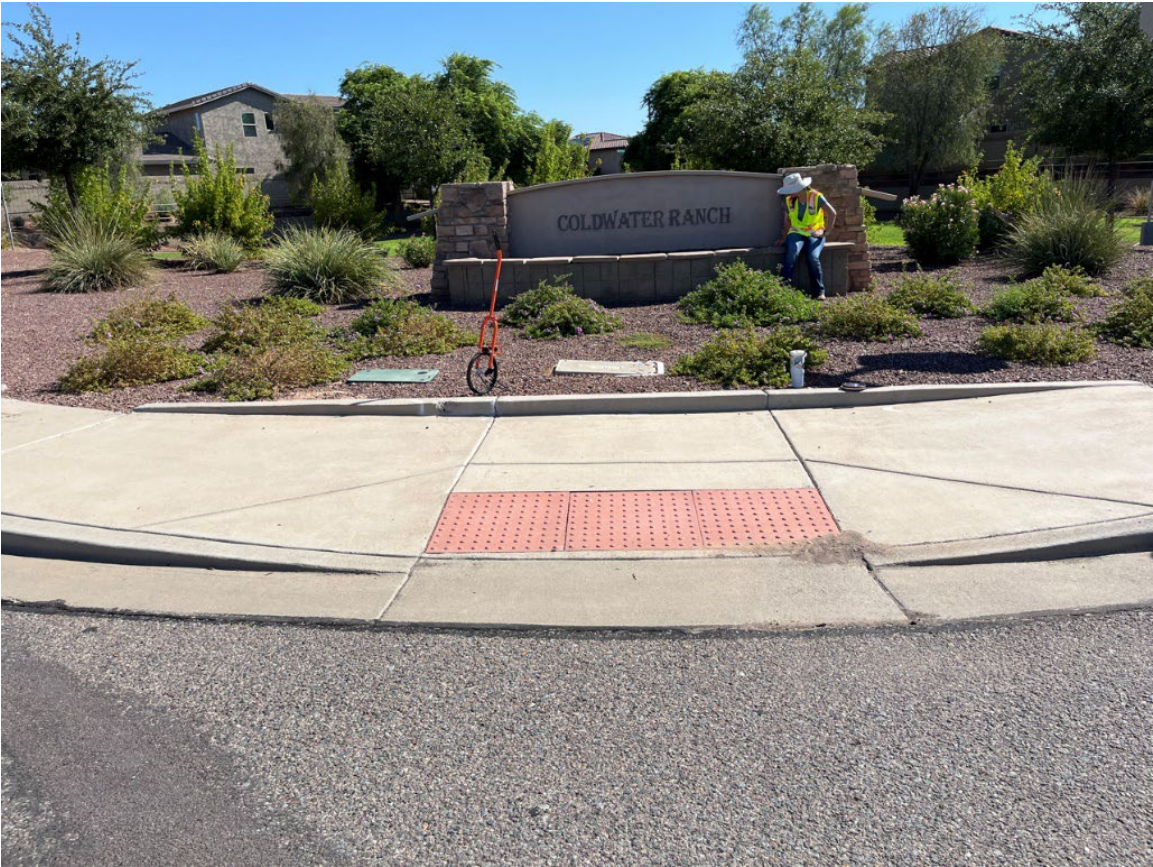
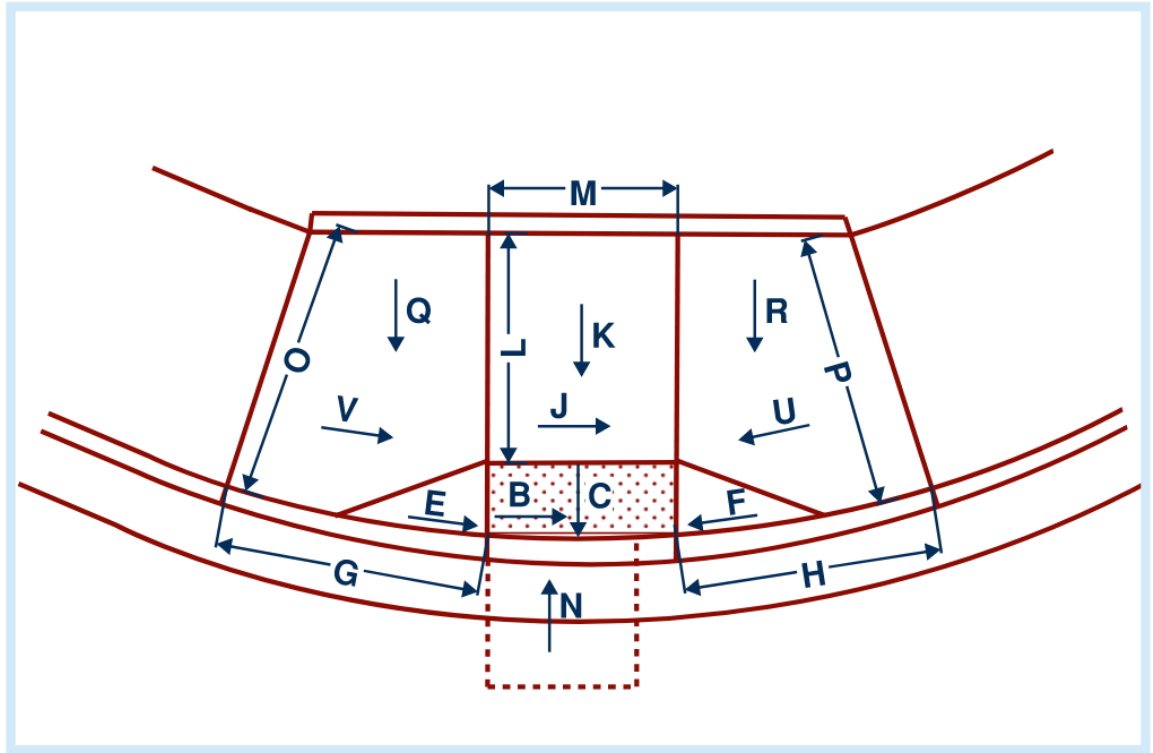
## Curb Ramp 5

**Comments**  
Horizontal gaps in panels approximately 1". Wear present on curb and warning Surface.

| Facility ID | Feature not Meeting PROWAG | Proposed Remediation |
|---|---|---|
| R-5 | Landing length is less than 48" | Reconstruct curb ramp |

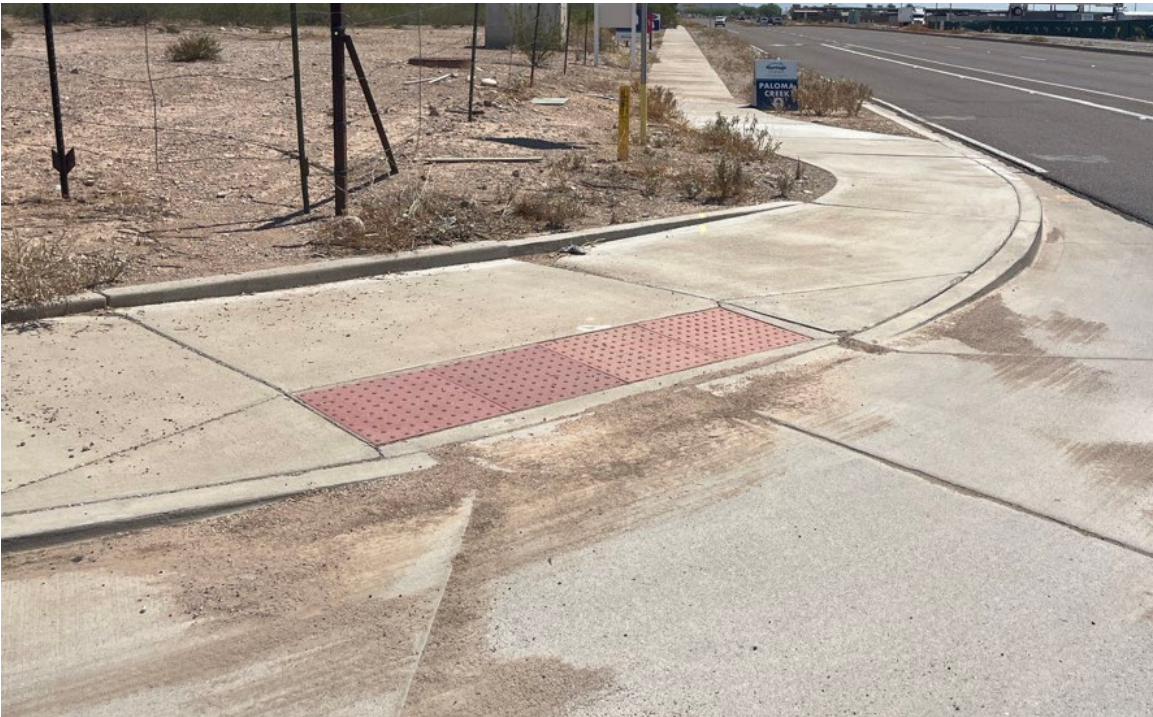
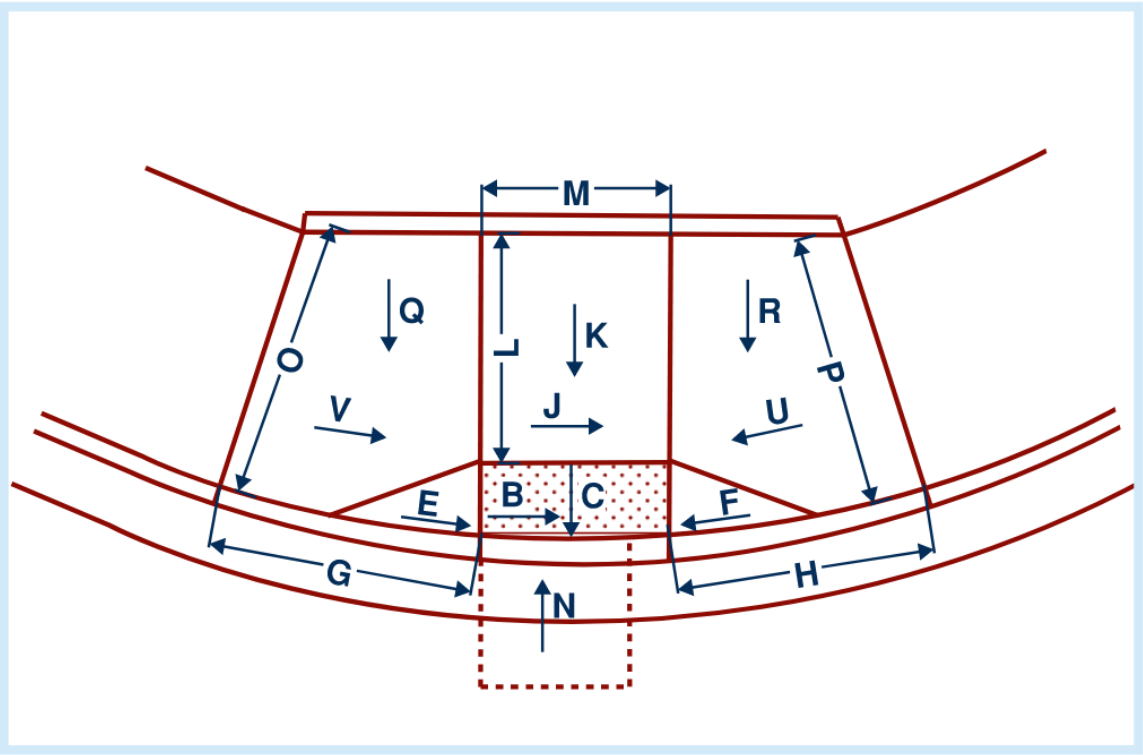
## Curb Ramp 7

**Comments**  
Rock and dirt observed on ramp surface.

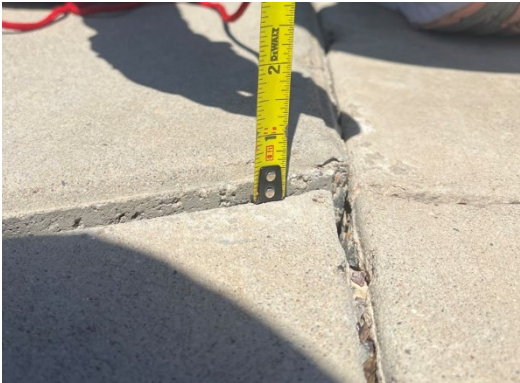
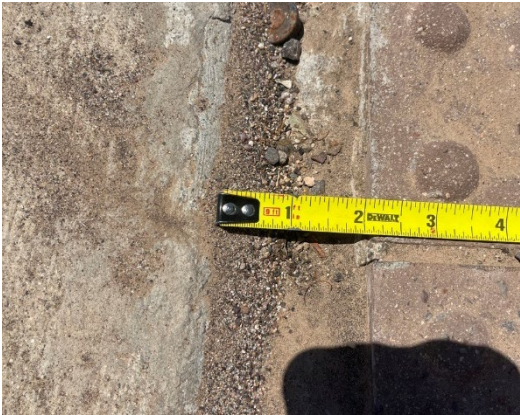
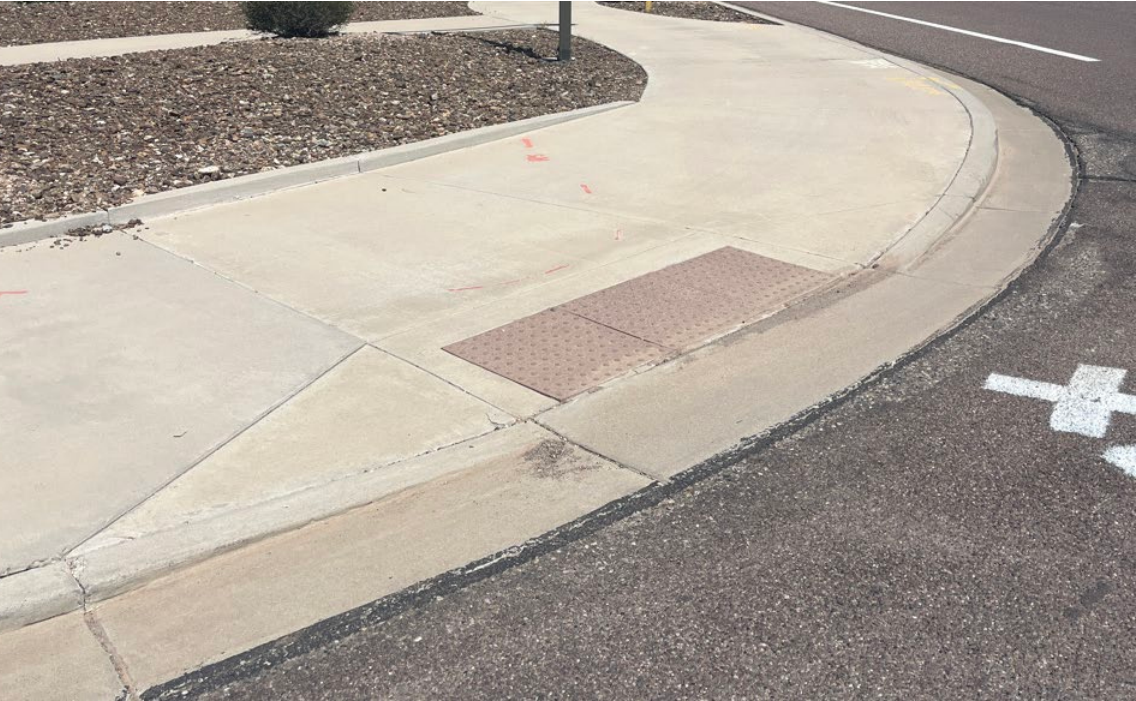
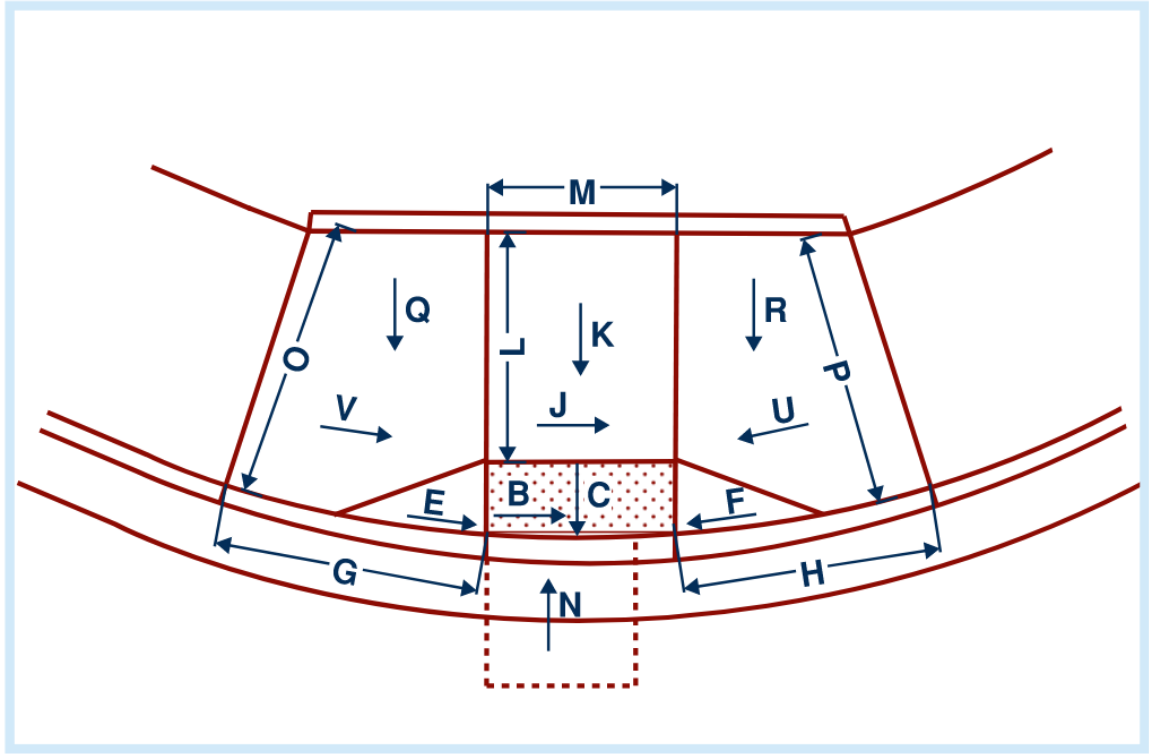
## Curb Ramp 8

**Comments**  
Concrete at base of ramp has deteriorated creating a horizontal opening greater than 1/2". Vertical openings greater than 1/4".

Ramp is non-compliant due transitions not being flush, including vertical openings greater than 1/4" and horizontal openings greater than 1/2".

| Facility ID | Feature not Meeting PROWAG | Proposed Remediation |
|---|---|---|
| R-8 | Transitions not flush. Concrete damage at base of detectable warning surface causing horizontal opening greater than 1/2" | Bevel transitions to be flush |

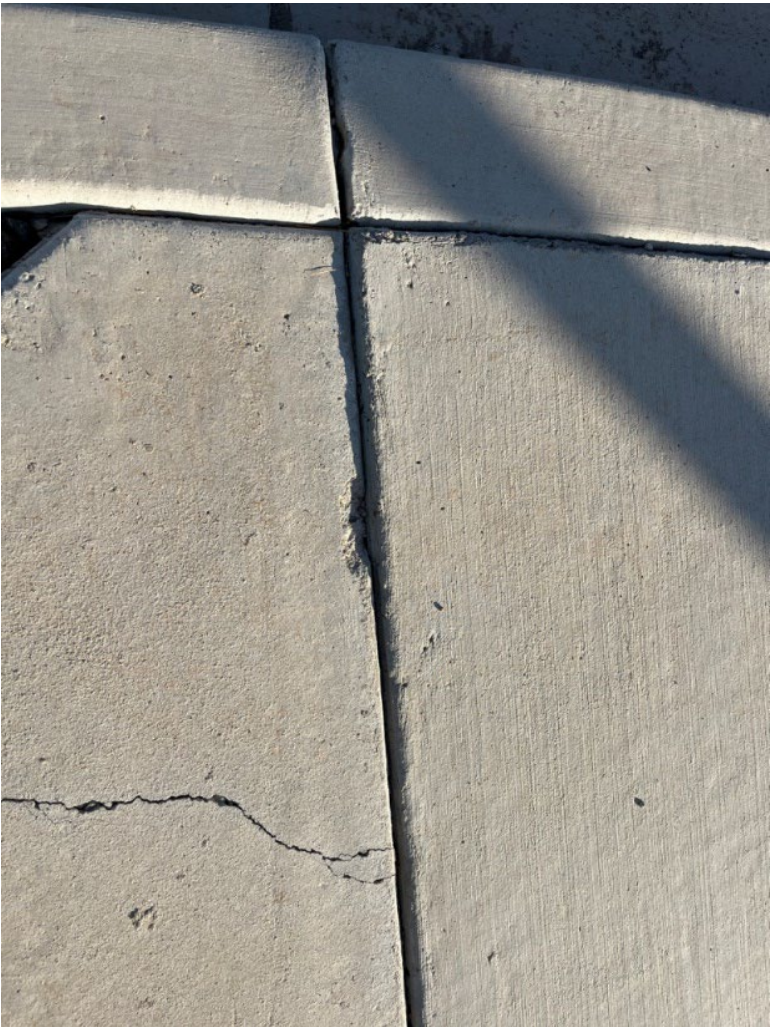
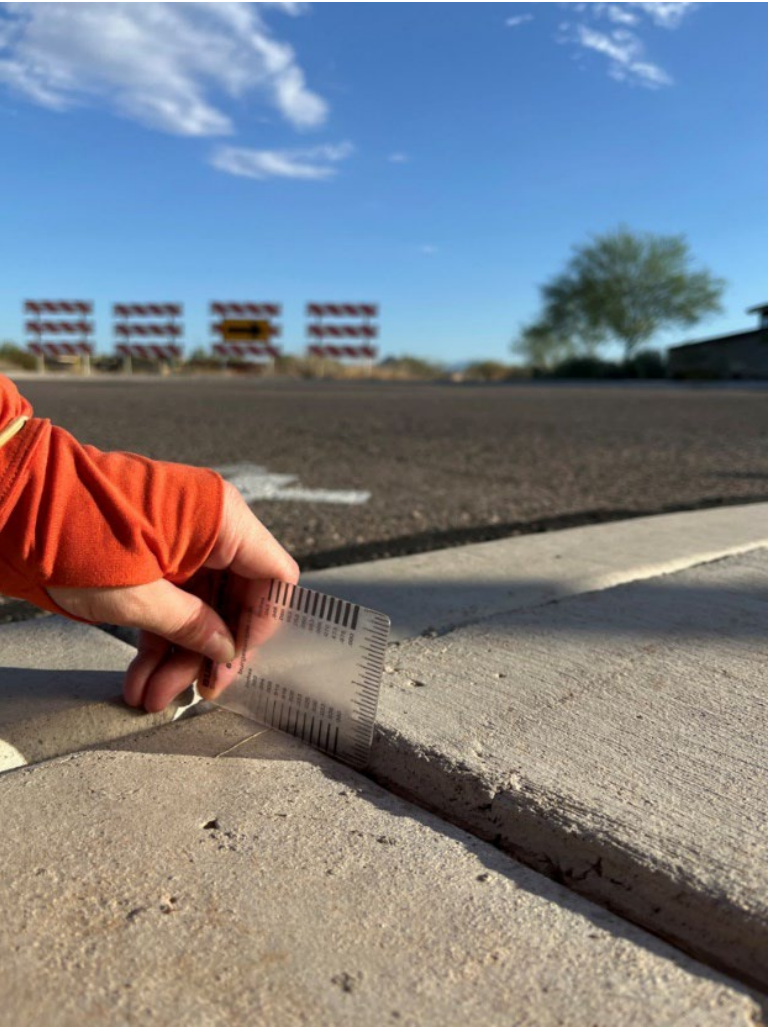
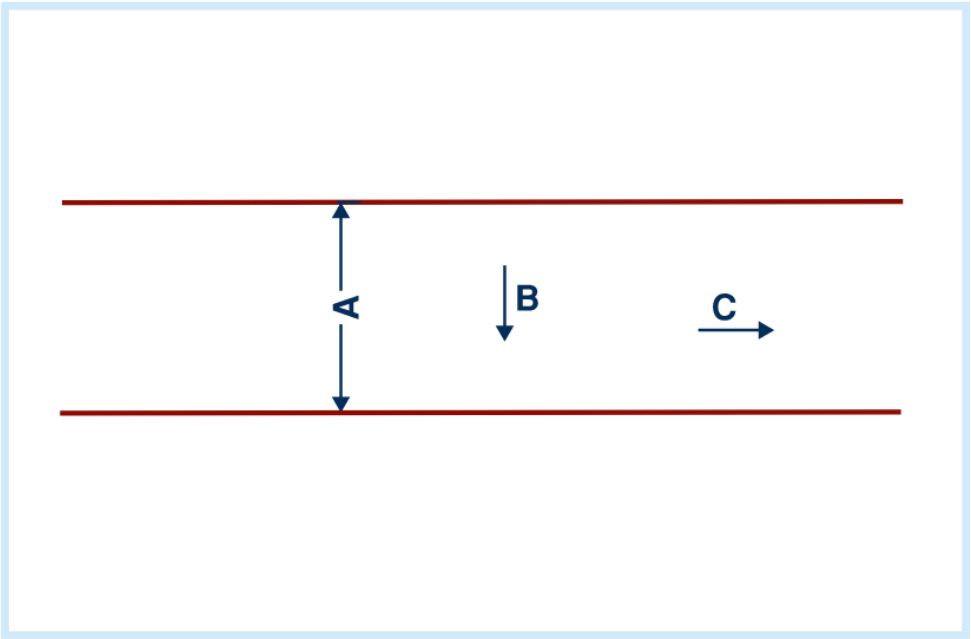
**Comments:** Change in level and cracking at joints. Sidewalk is attached at intersection. If crossing is prohibited, sidewalk should be buffered, or vertical separation should be added. If crossing is permitted curb ramp should be constructed.

| Facility ID | Feature not Meeting PROWAG | Proposed Remediation |
|---|---|---|
| S-1 | Sidewalk attached to curb at intersection where no curb ramp is present and vertical change between panels greater than 1/4" | If crossing is permitted curb ramp should be constructed. If crossing is prohibited, sidewalk should be buffered, or vertical separation should be added. |

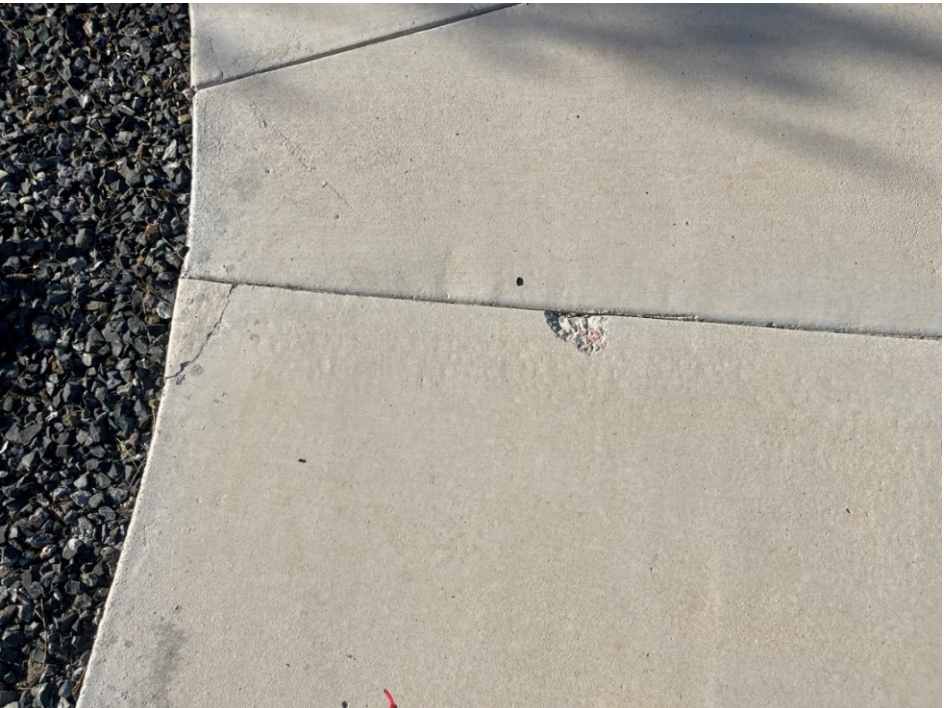
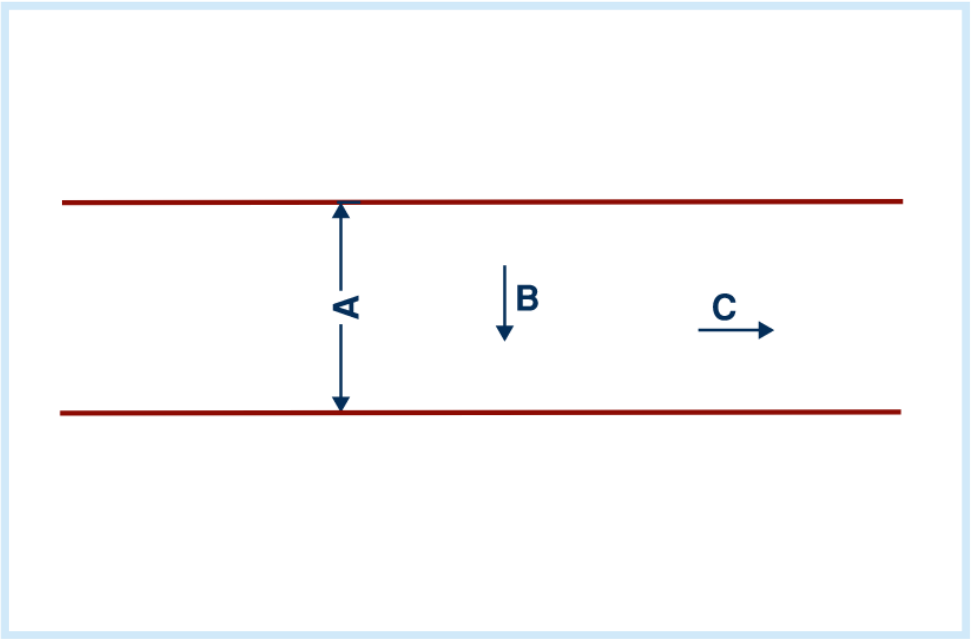
## Sidewalk 4

**Comments:** Texture and cracking present along edge closest to El Mirage Rd.

| Facility ID | Feature not Meeting PROWAG | Proposed Remediation |
|---|---|---|
| S-4 | Horizontal opening greater than 1/2" | Reconstruct sidewalk |

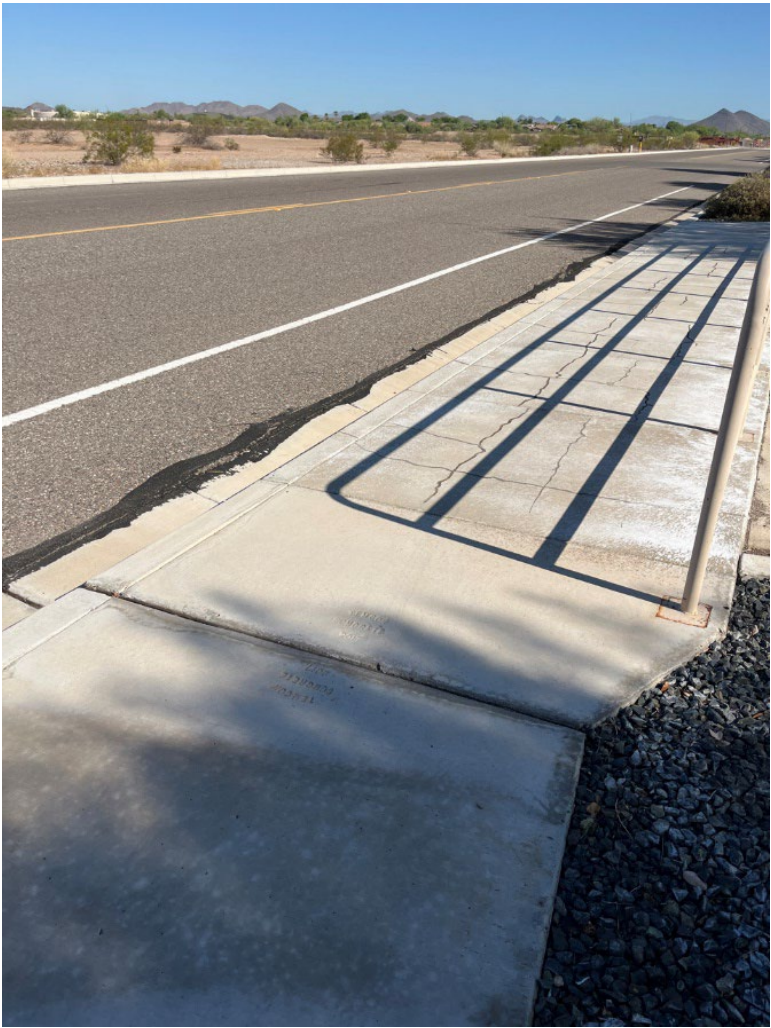
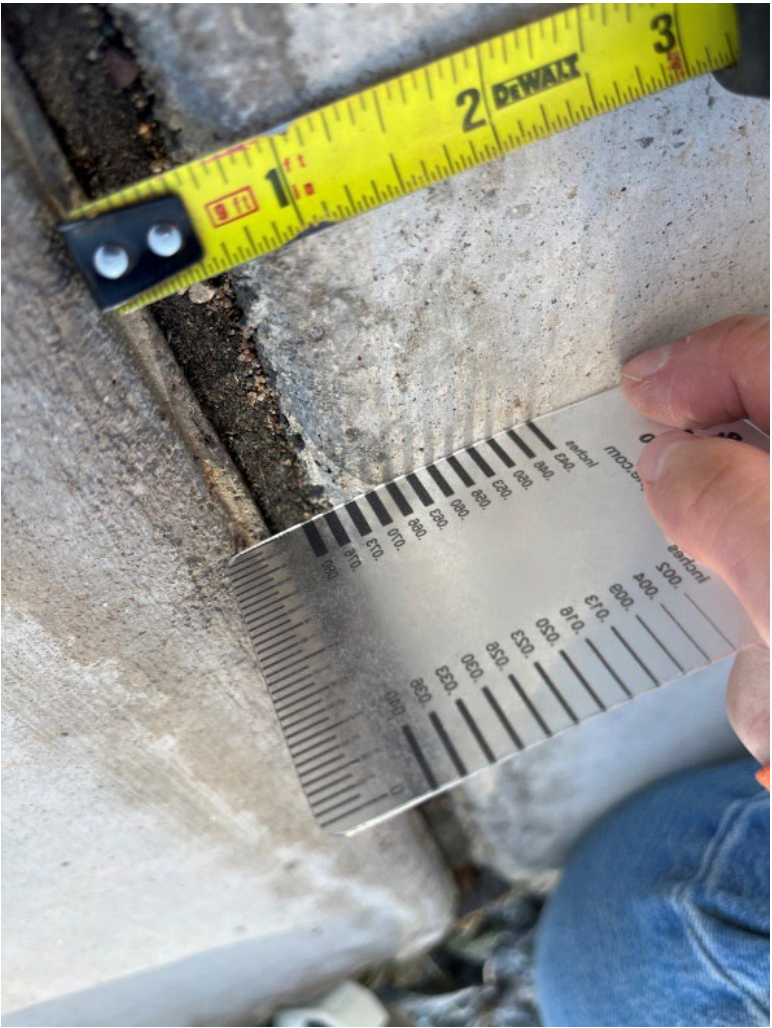
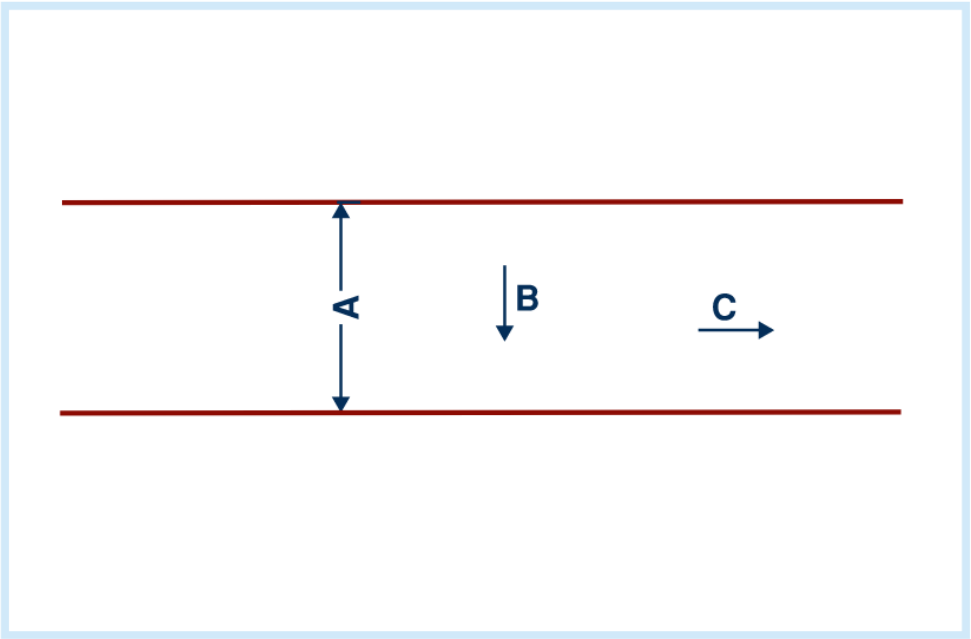
## Sidewalk 7

**Comments:** Minor cracking present on panels.

| Facility ID | Feature not Meeting PROWAG | Proposed Remediation |
|---|---|---|
| S-7 | Horizontal opening greater than 1/2" | Reconstruct sidewalk |

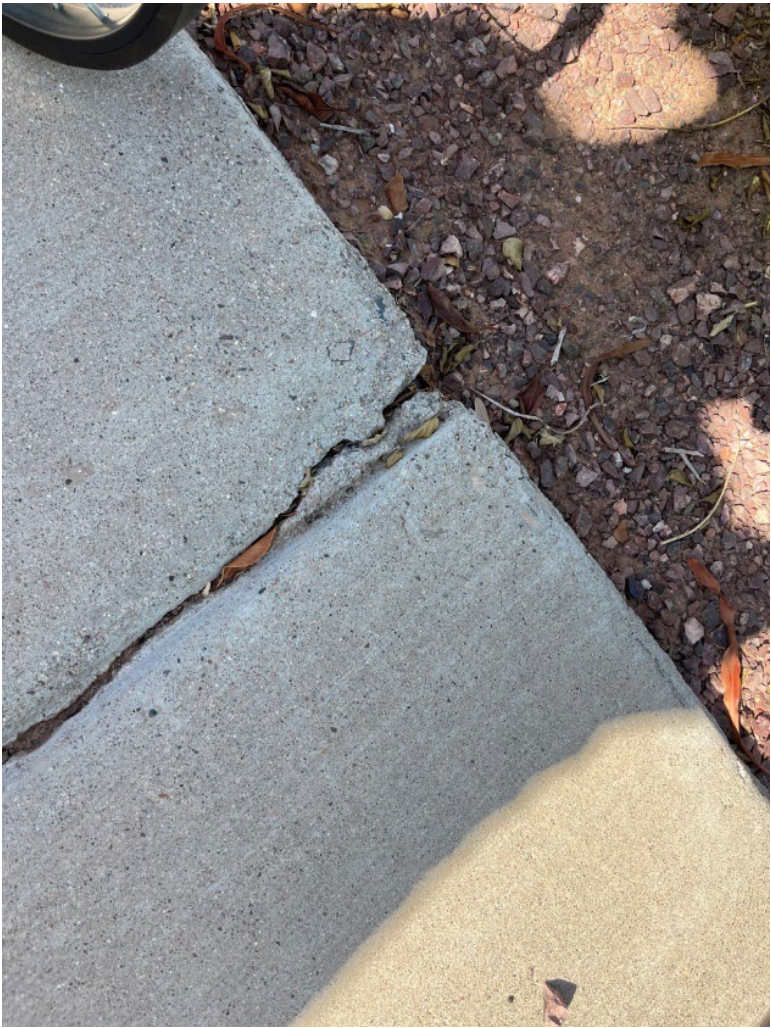
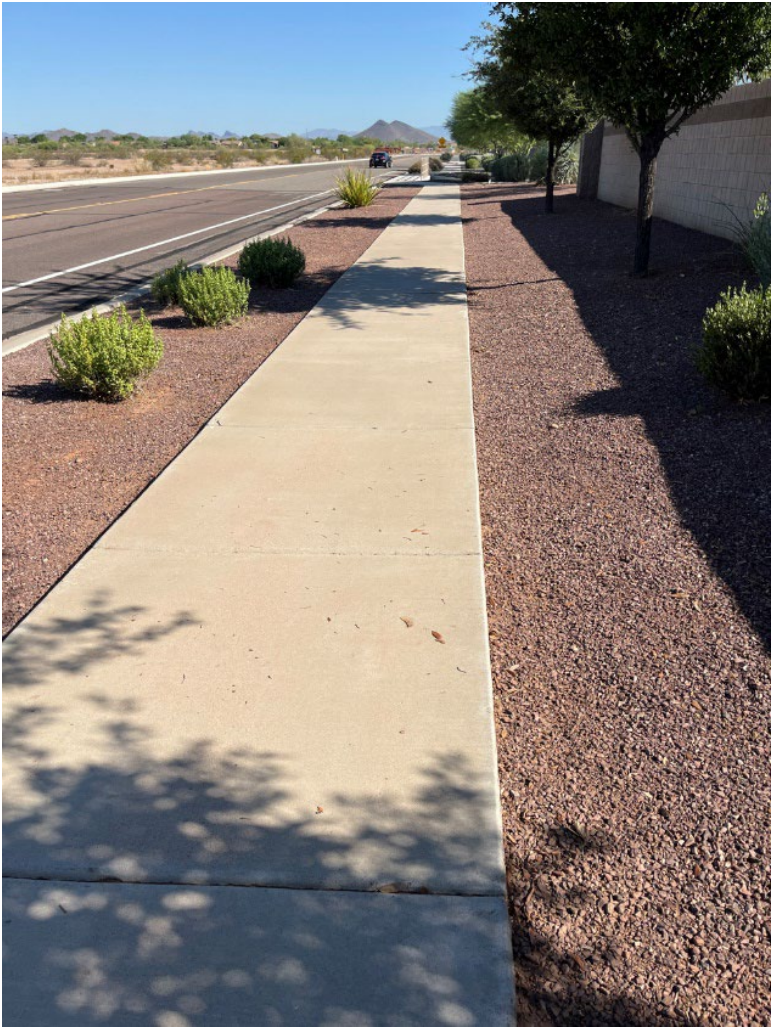
Sidewalk 9

Comments: Edge crack present.

| Facility ID | Feature not Meeting PROWAG | Proposed Remediation |
|---|---|---|
| S-9 | Horizontal opening greater than 1/2" at panel edge | Repair damaged edge |

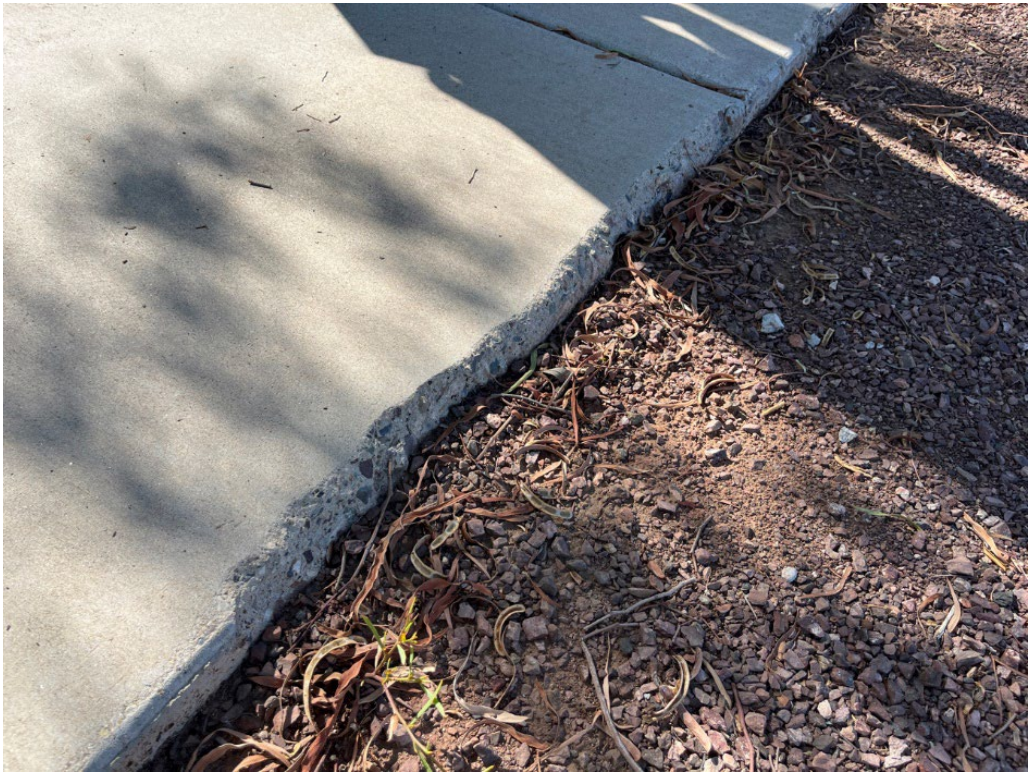
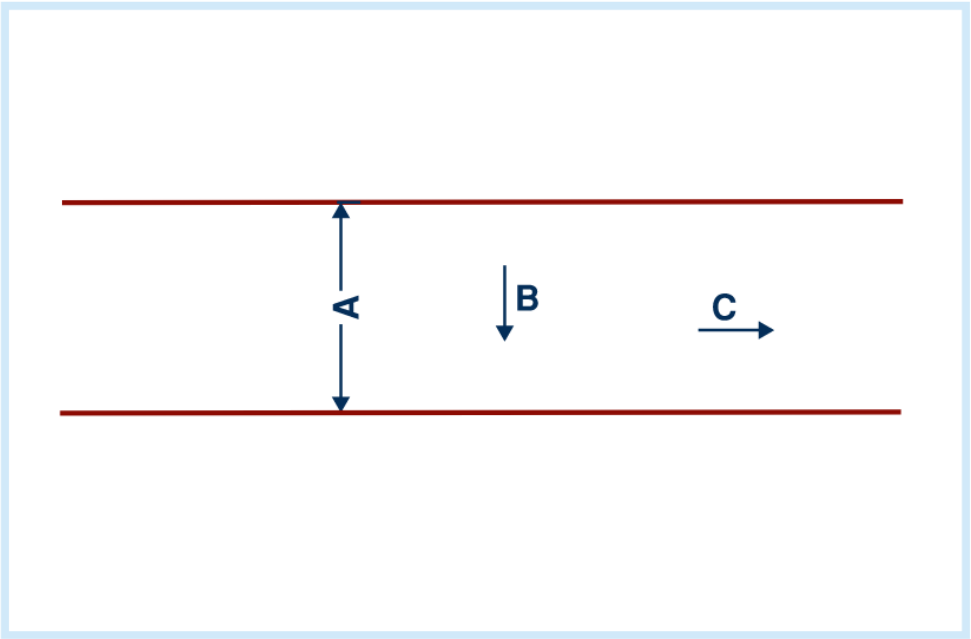
## Sidewalk 10

**Comments:** Edge damage observed.
