# *El Mirage Rd; 303L – Jomax Road Design*

## *ADA Compliance and Feasibility Report*

ADOT Project No: T0428 03D

Contract No: 2024-001

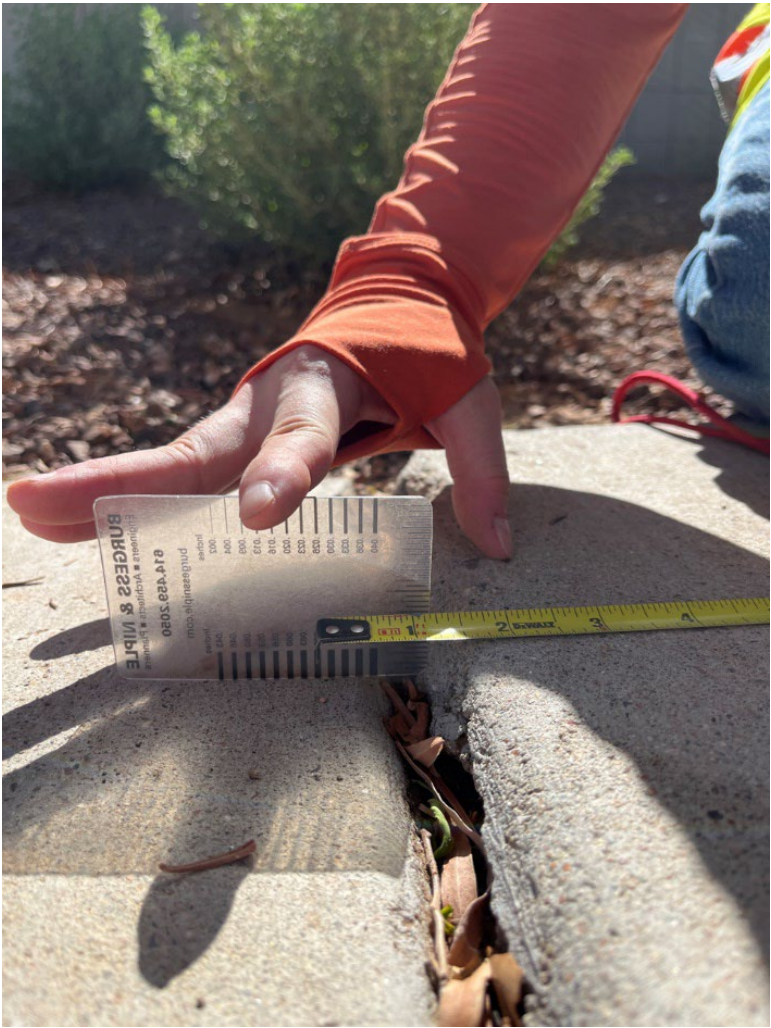
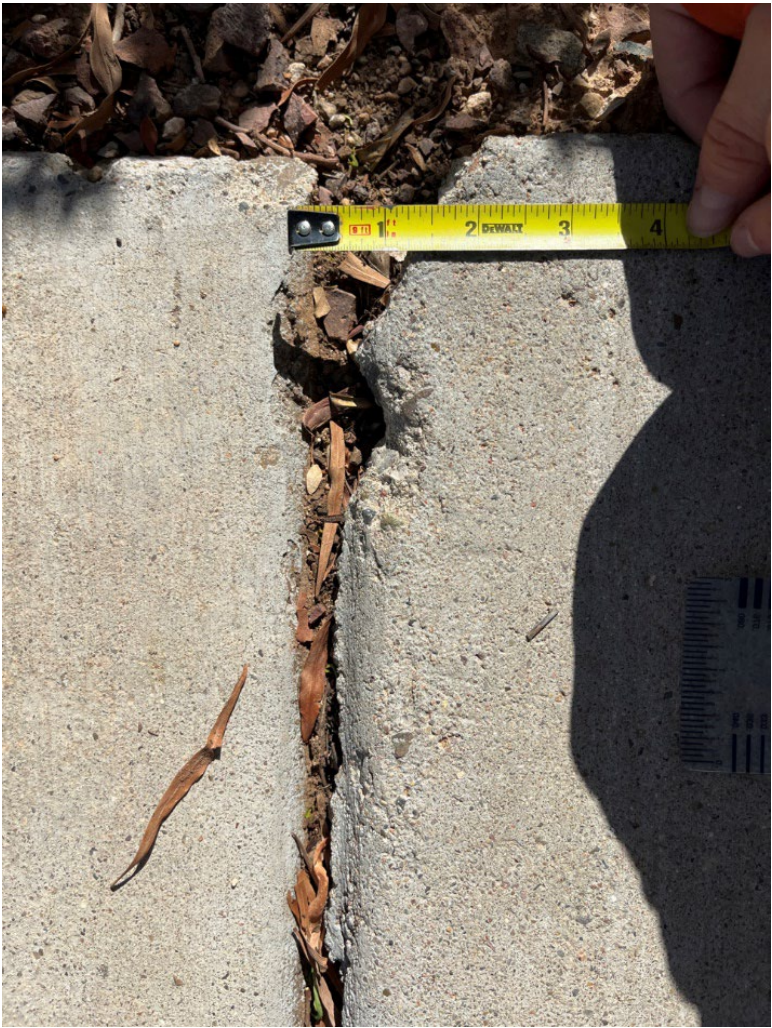
Sidewalk 11

Comments: Edge damage observed.

| Facility ID | Feature not Meeting PROWAG | Proposed Remediation |
|---|---|---|
| S-11 | Vertical change between panels greater than 1/4", edge damage | Reconstruct sidewalk |

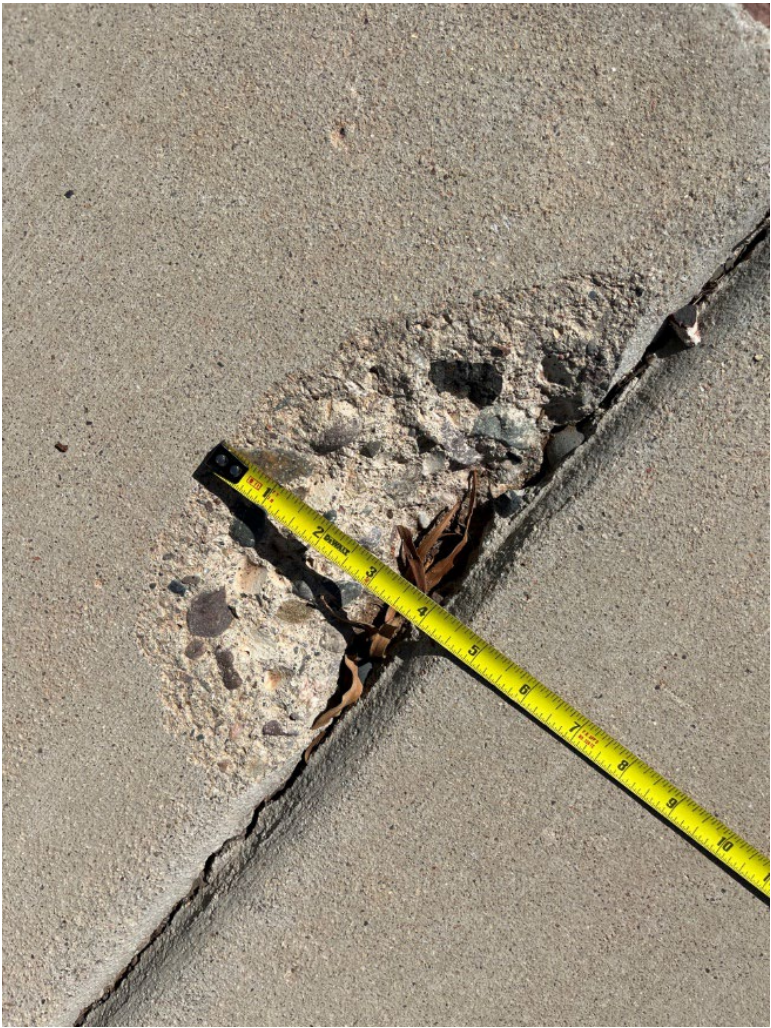
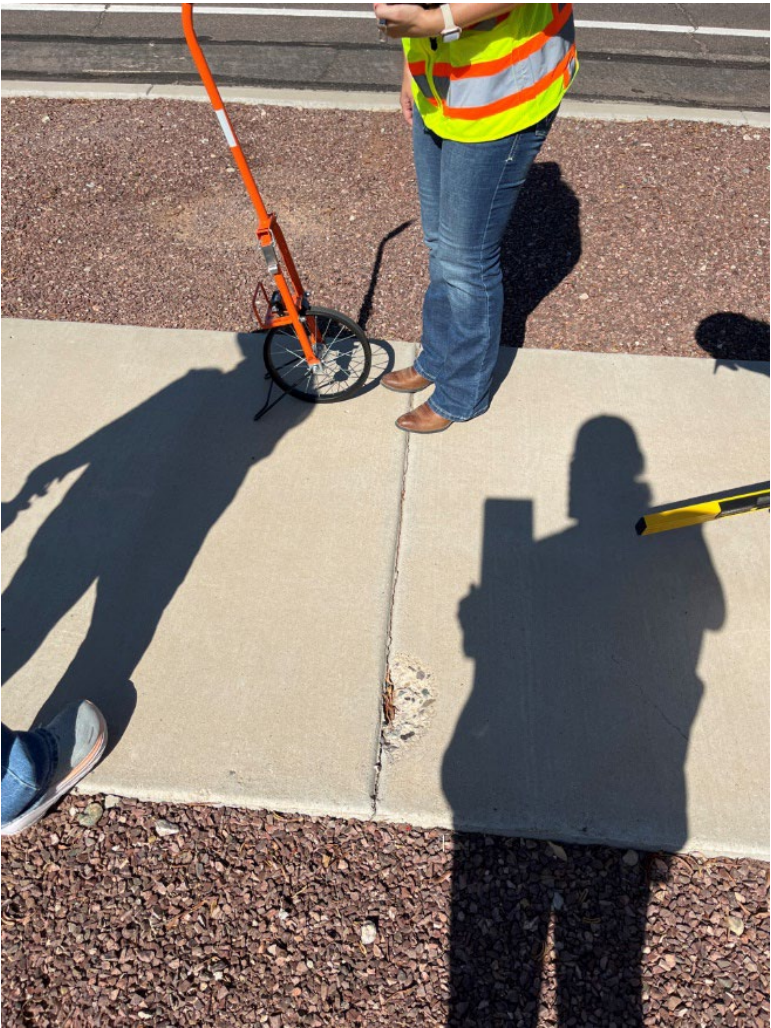
Sidewalk 13

Comments: Damage at joint causing 4.5” horizontal opening.

| Facility ID | Feature not Meeting PROWAG | Proposed Remediation |
|---|---|---|
| S-13 | Damage at joint causing horizontal opening greater than 1/2" | Repair damaged concrete location or reconstruct sidewalk |

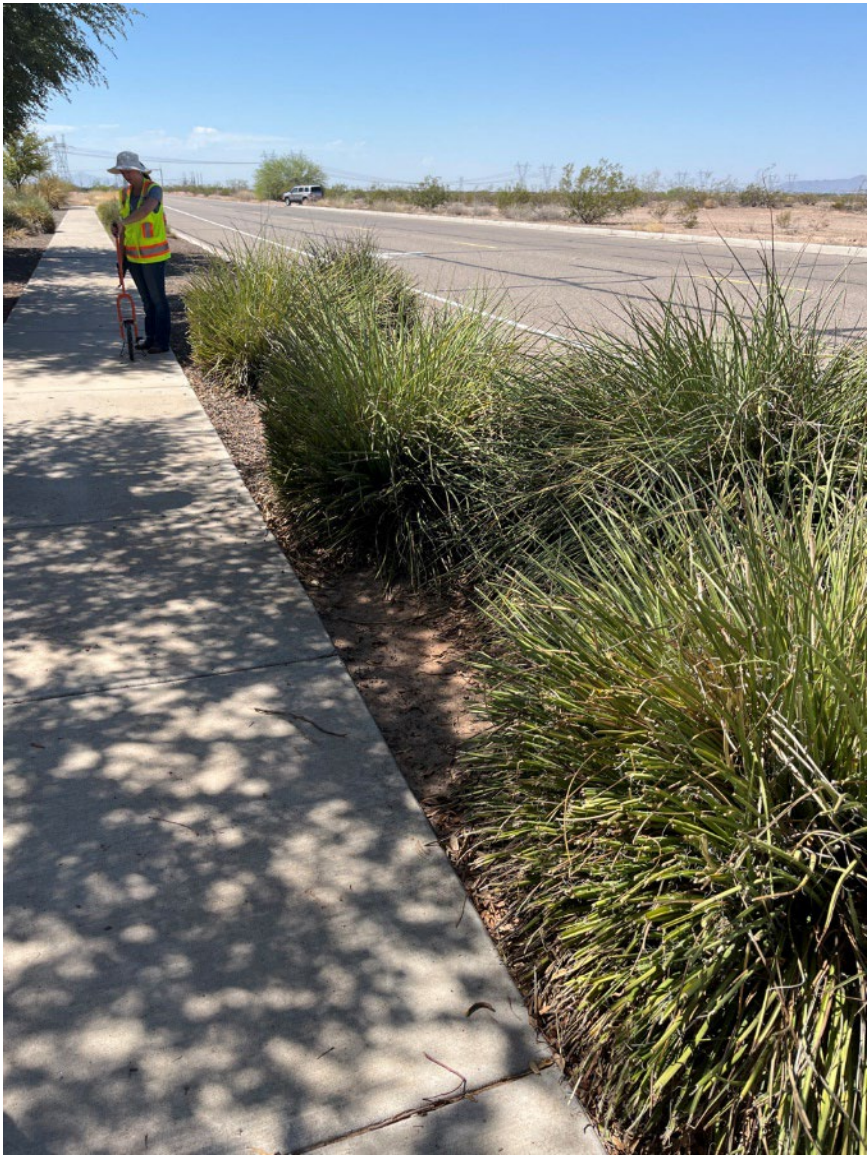
**Comments:** Significant change in longitudinal slope between panels. Minor edge damage along three panels running south. Bushes trimmed back could be obstruction if not.
