# *El Mirage Rd; 303L – Jomax Road Design*

## *ADA Compliance and Feasibility Report*

ADOT Project No: T0428 03D

Contract No: 2024-001

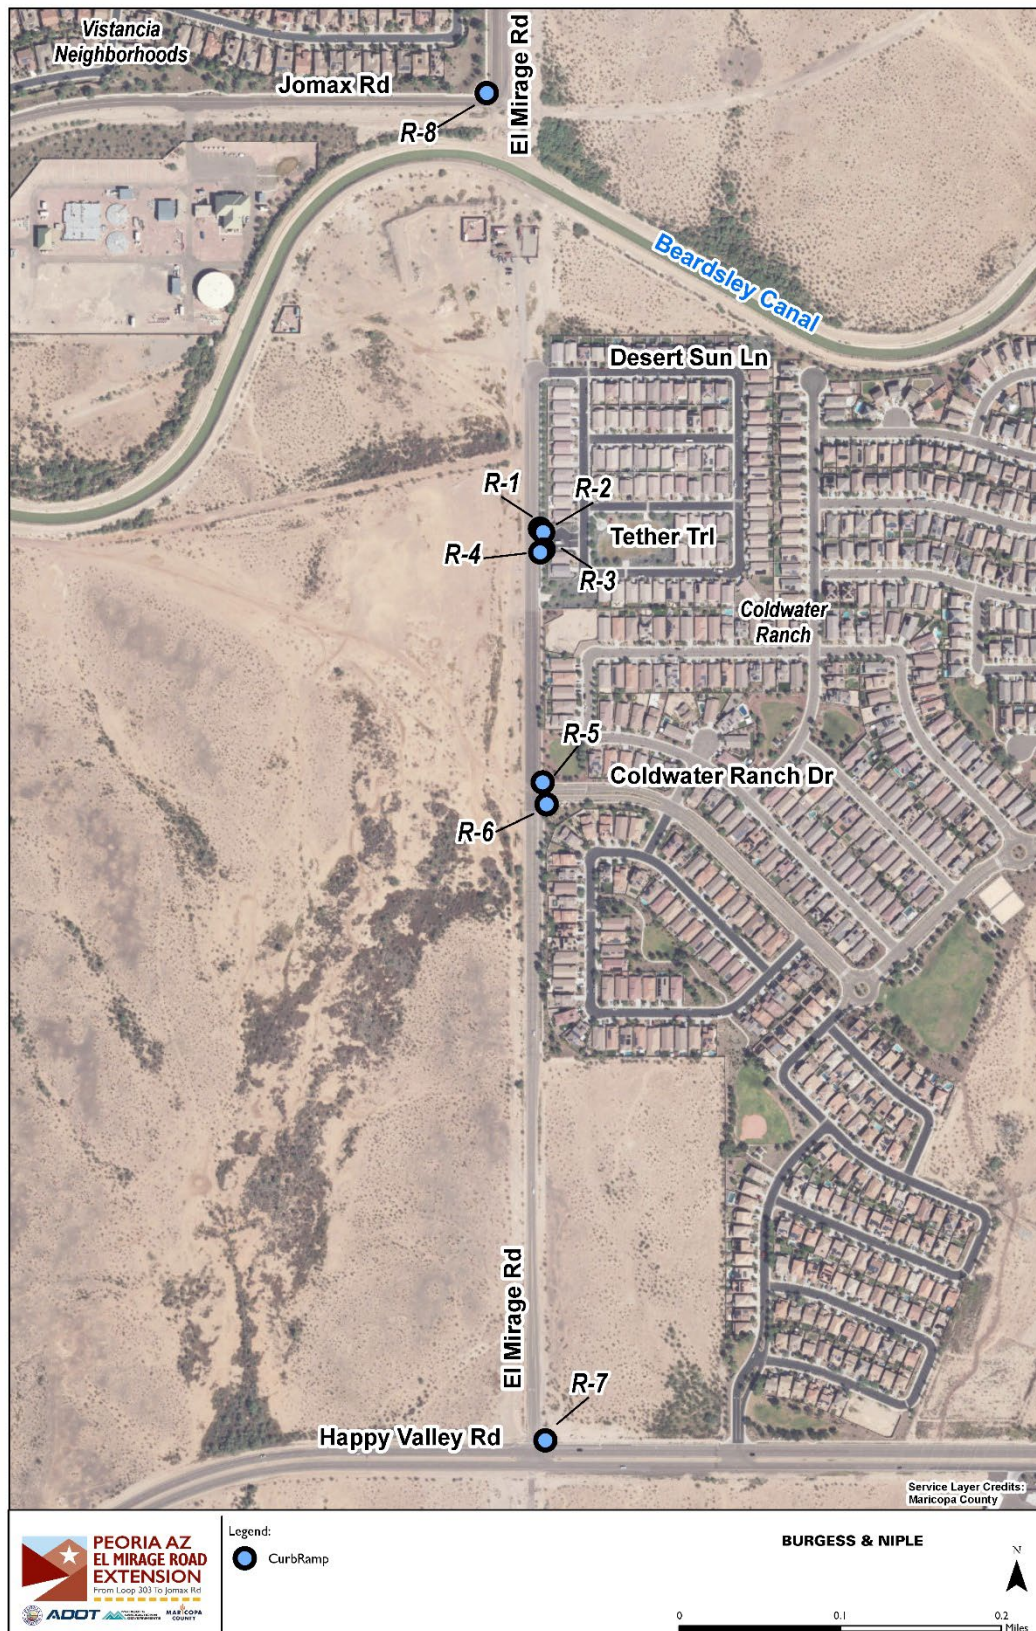
Figure 2: Pedestrian Curb Ramp Locations

A total of eight curb ramp locations throughout the project area were evaluated against the PROWAG technical requirements for pedestrian curb ramps presented in **Table 3**. **Figure 2** illustrates the pedestrian curb ramp locations within the project area. Two of the eight curb ramp locations met the PROWAG requirements approved by the United States Access Board September 7, 2023. Field data collected for each curb ramp location is provided in **Appendix A**.

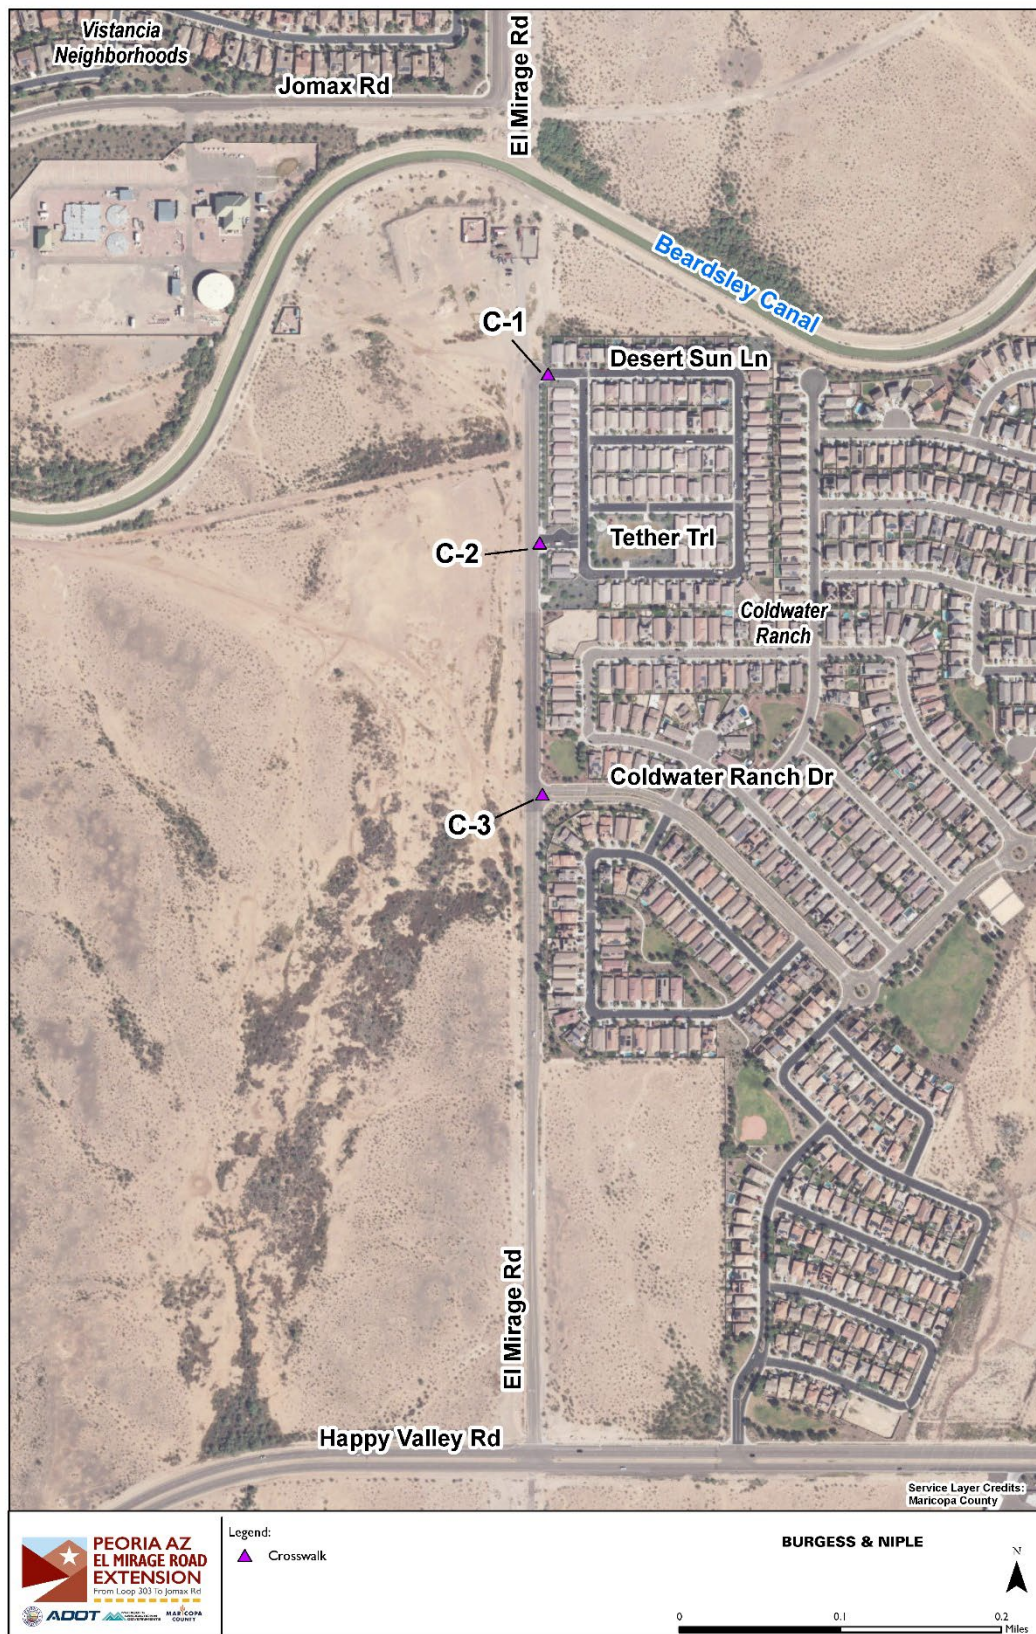
Figure 3: Crosswalk Locations

A total of three unmarked crosswalk locations throughout the project area were evaluated against the PROWAG technical requirements for crosswalks are presented in **Table 4**. The crosswalk locations are defined as C-1, C-2, and C-3 and are illustrated in **Figure 3**. Two of the three pedestrian crossing locations met the PROWAG requirements approved by the United States Access Board September 7, 2023. Field data collected for each crosswalk location is provided in **Appendix B**.

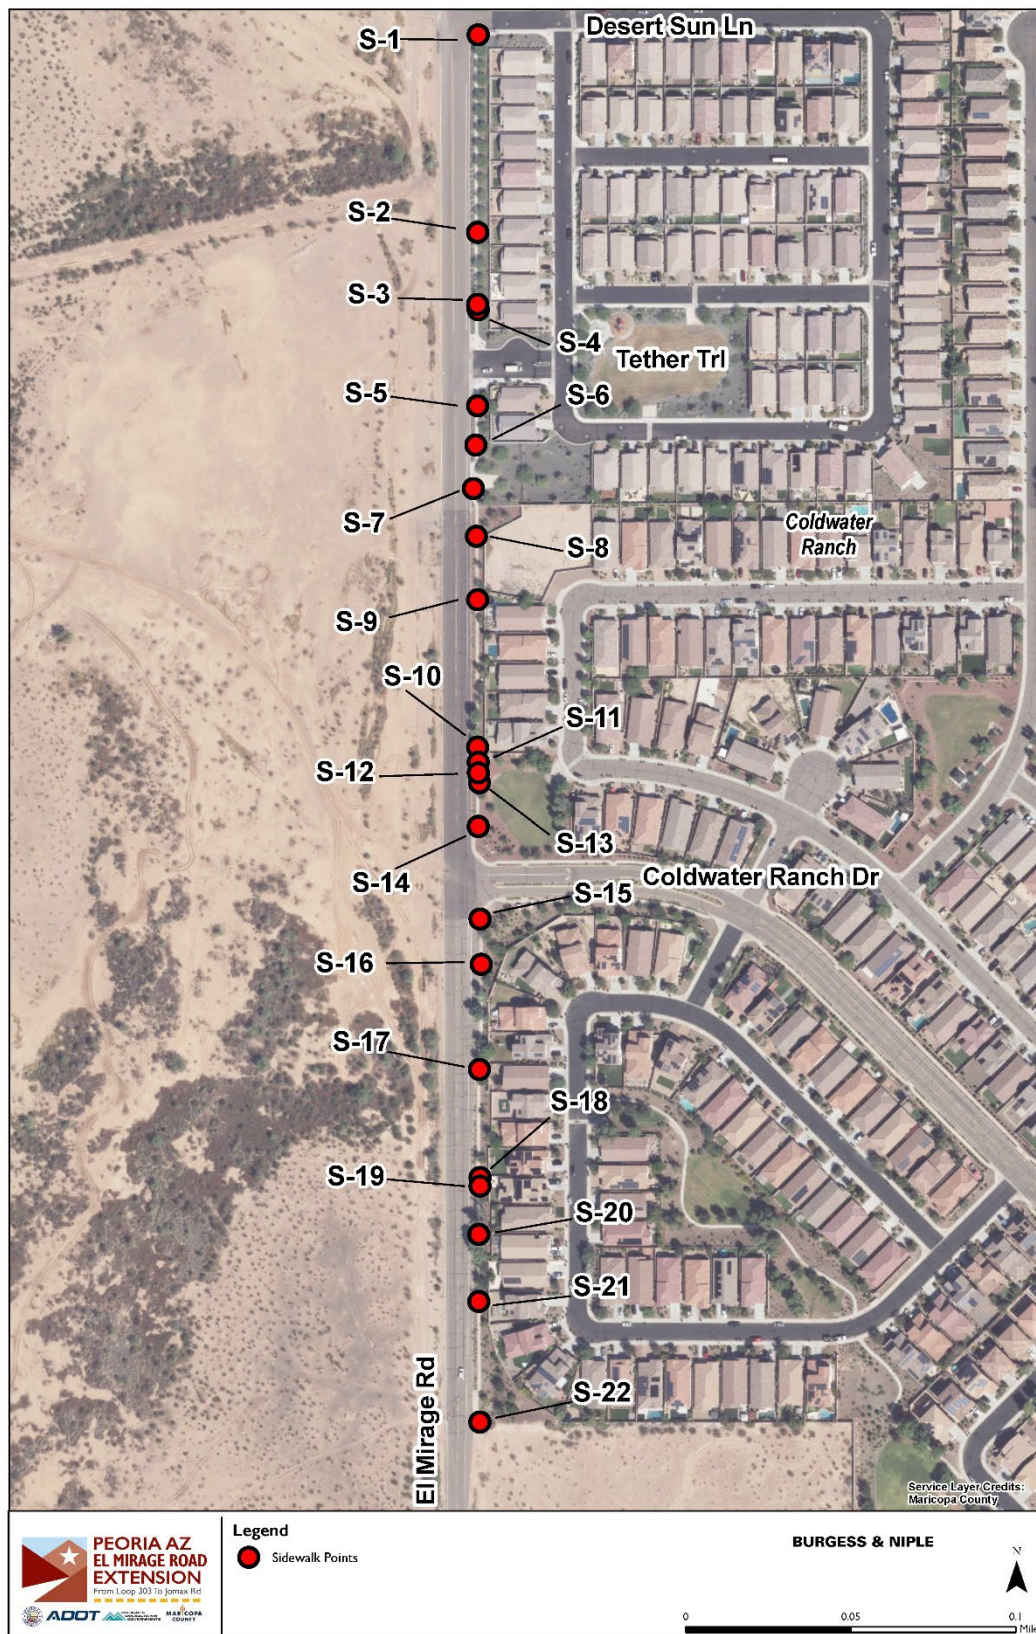
Figure 4: Sidewalk Locations

A total of 22 sidewalk spot locations throughout the project area were evaluated against the PROWAG technical requirements presented in **Table 5**. Sidewalk locations are illustrated in **Figure 4**. Six of these locations met the PROWAG requirements approved by the United States Access Board September 7, 2023. There were multiple locations with approximate one-inch gaps between the panels. Field data collected for evaluated sidewalk facilities are provided in **Appendix C**.

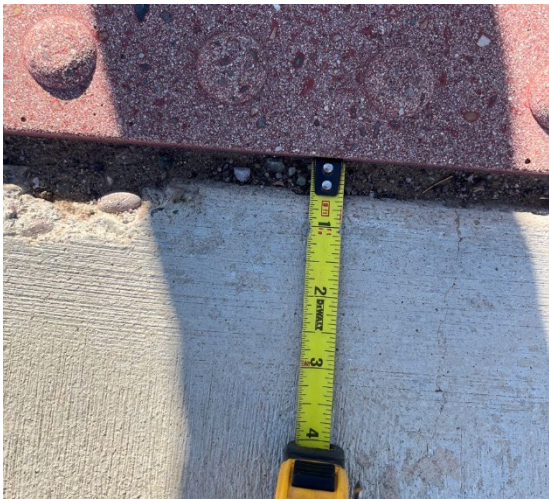
**Comments**  
Vertical (<1/4”) and horizontal gap (>1/2”) between detectable warning and base of ramp.

Ramp is non-compliant due to horizontal gaps greater than 1/2”.

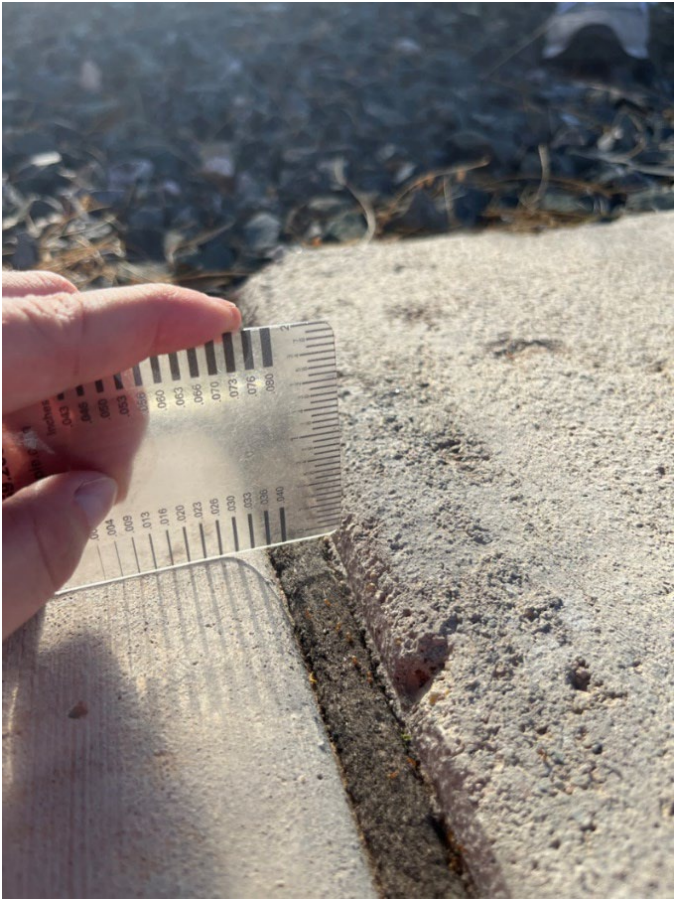
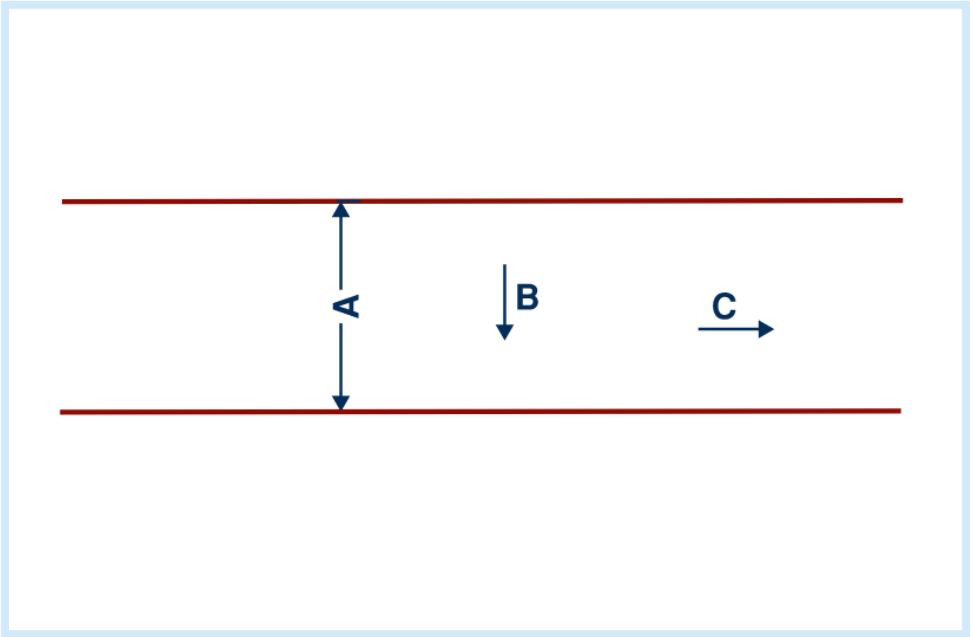
| ID | Feature | Results | Units |
|---|---|---|---|
| | Horizontal Opening Greater than 1/2”? | Yes | |

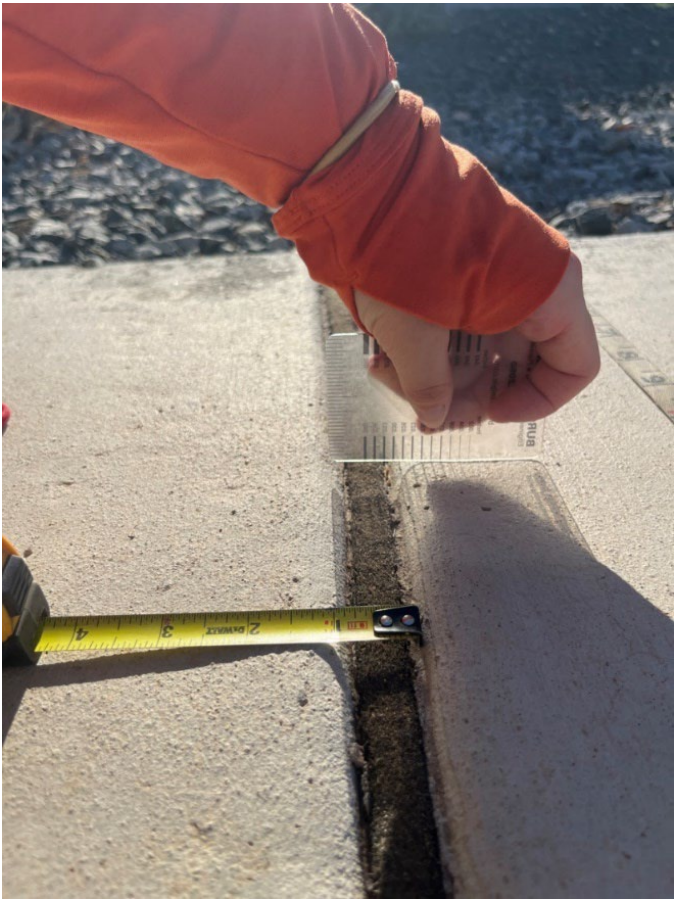
| ID | Feature | Results | Units |
|---|---|---|---|
| | Horizontal Opening Greater than 1/2"? | Yes | |
